**Indian Summer Residential Community
Pavement Maintenance and Repair Prioritization Plan (2014 – 2017)**
August 30, 2013

Vantage Community Management
Barbara Brauser
202 Central Street NE, Suite 140
Olympia, WA 98506

PAVEMENT SERVICES, INC.
3835 NE Tillamook Street
Portland, Oregon 97212
(503) 235-0377

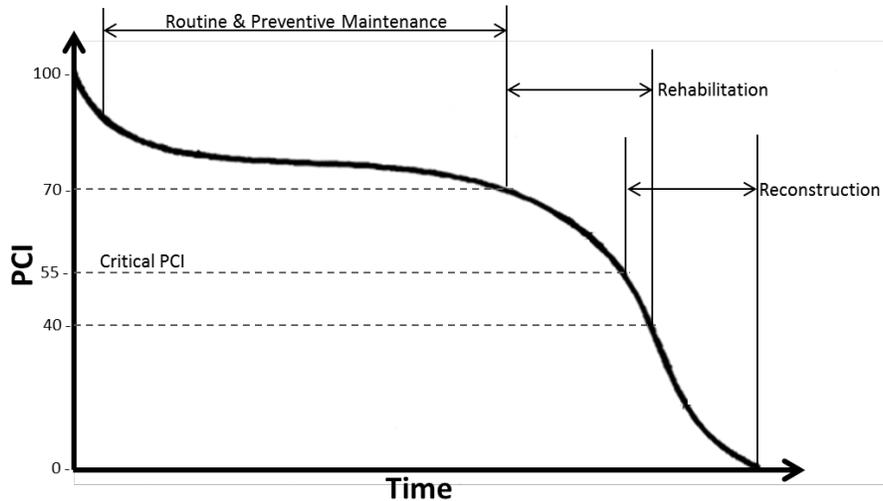
Figure 1. Maintenance Activity by Condition

Maintenance and repair (M&R) activities are typically triggered by the condition or PCI of a pavement. Recognized PCI levels that trigger maintenance are in Figure 1. There are three categories of M&R: localized, global, and major.¹ Localized and global maintenance are both types of routine and preventive maintenance. Preventative maintenance is used to maintain pavements that have a high PCI. This range is commonly from 70 to 100. Major M&R includes both rehabilitation and reconstruction. Rehabilitation activities occur at a PCI of 70 or lower and include activities such as thin overlay or resurfacing. Pavements that reach the critical PCI require major M&R. Critical PCI is the point at which the rate of PCI loss increases with time and the application of preventive maintenance is no longer cost effective¹.

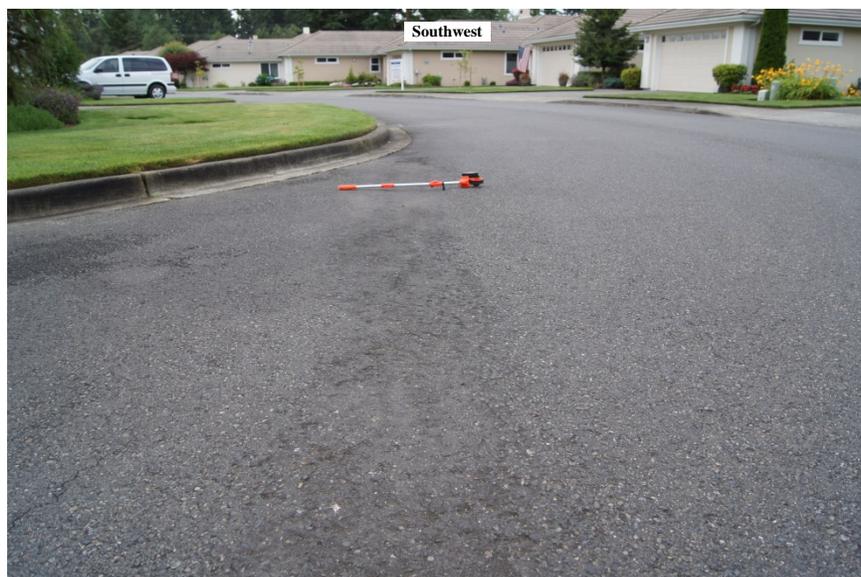
A depression is located in the pull out near the mailboxes on Fairway Lane (Figure 2). The depression occurs where the paving joint of the roadway and the pull out area meet. Currently, the depression is only causing a decreased ride quality. If the depression becomes more severe, PSI recommends ISRC remove the pavement in the affected area, properly compact the base or subgrade material, and replace with new AC.

Figure 2. Depression on Fairway Lane near mailboxes

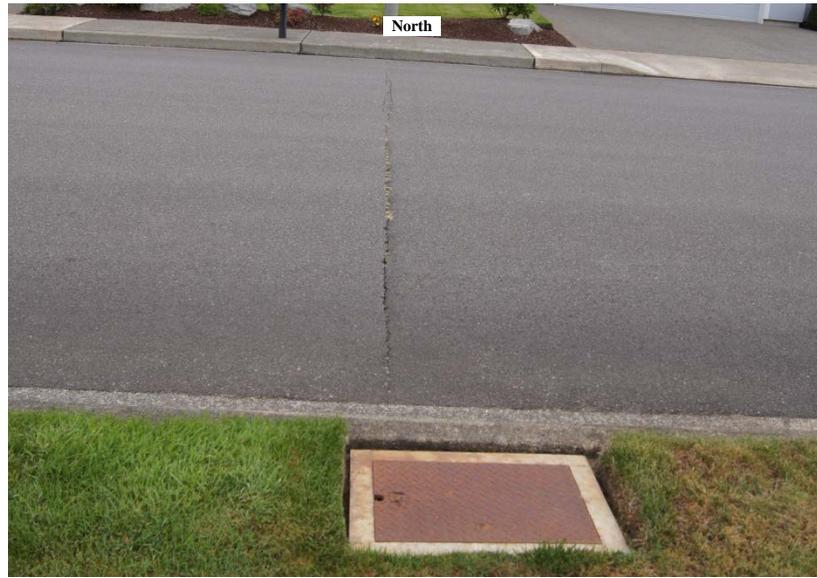
Multiple cracks have formed transversely across the street. The cracks appear to have formed above a buried storm sewer. We recommend repairing the smaller width cracks ($\frac{1}{4}$ to 1 inch) with crack sealant. We recommend patching areas where secondary cracks or alligator cracking have formed. The distressed area should be removed, the base or subgrade properly compacted, and the area patched with new AC. Figure 3 shows an example of a crack that should be repaired with a patch.

Figure 3. Transverse cracking on Prestwick Lane

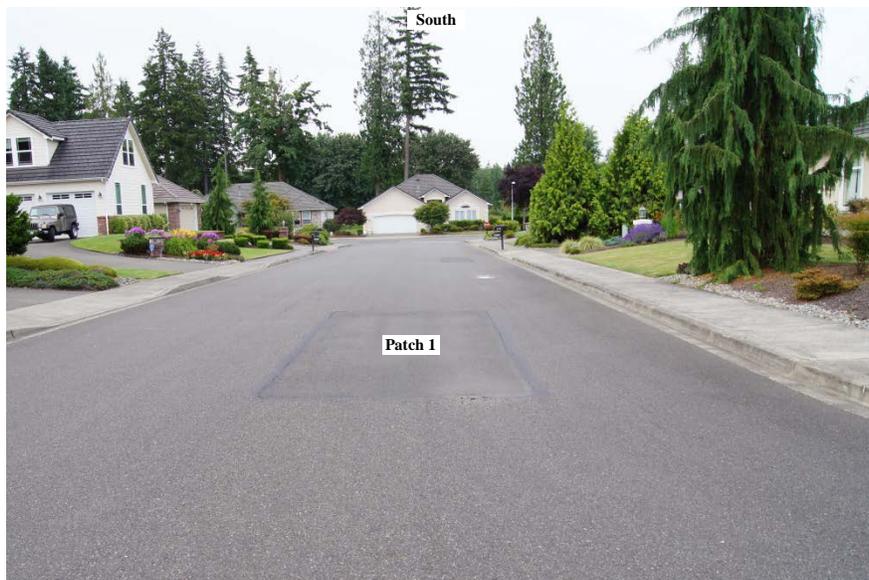
We understand that Patch 1 south of Carnoustie Court on Turnberry Lane was originally placed to remove fatigued pavement. New alligator cracking has appeared on both ends of the patch as well as to the east of the patch. PSI recommends that ISRC remove the pavement across the full width of the street, properly compact the base or subgrade, and replace with new asphalt. The repair should begin approximately 10 feet south of the catch basin located on the east side of the road and extend 10 feet south of the driveway to House 6443 (Figure 5).

Figure 4. Patch 1 south of Carnoustie Court on Turnberry Lane

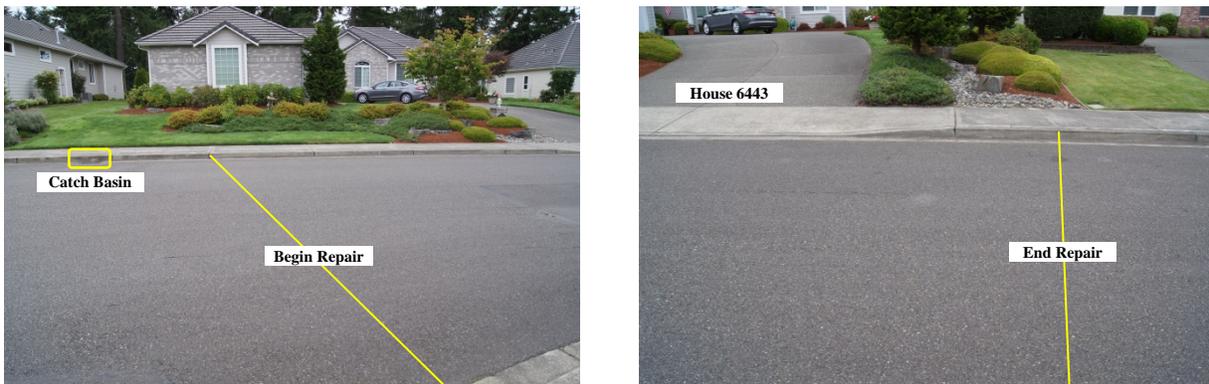
Figure 5. Recommended repair boundaries

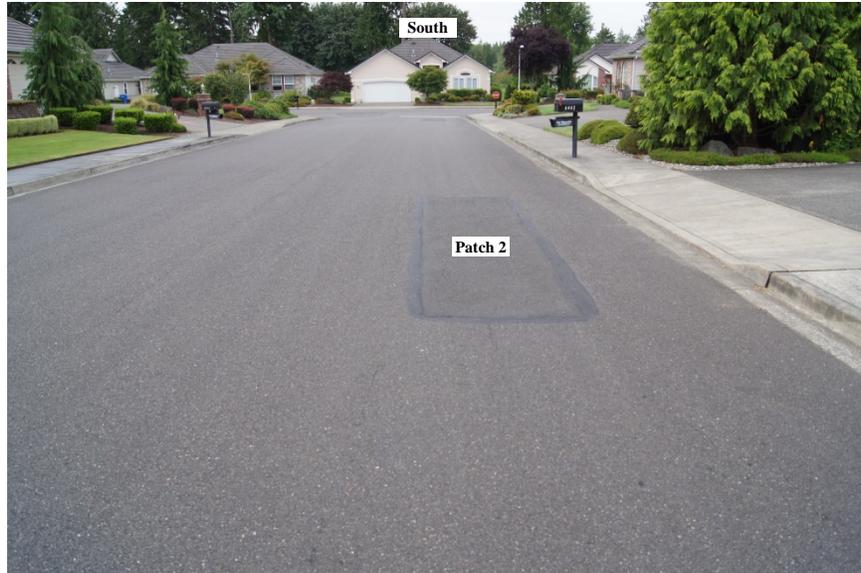
Patch 2 is located south of Patch 1, in front of House 6442 on Turnberry Lane. This area has alligator cracking around the perimeter of the patch. PSI recommends that ISRC remove the pavement from the curb to the road centerline, properly compact the base or subgrade, and replace with new AC. The repair should begin approximately 10 feet north of the driveway to House 6442 and extend to the south end of the driveway (Figure 7).

Figure 6. Patch 2 North of Prestwick Lane on Turnberry Lane

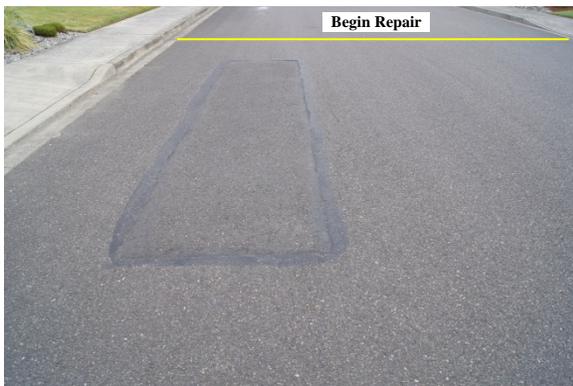
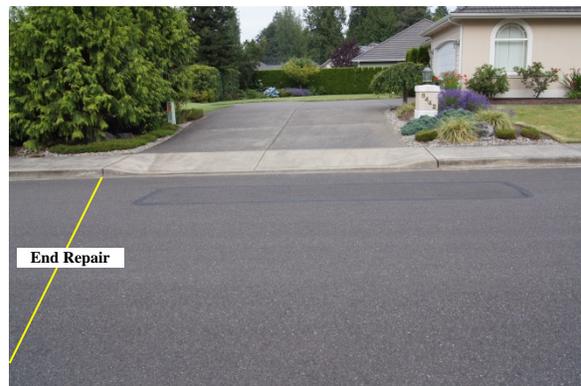
Figure 7. Recommended repair boundaries

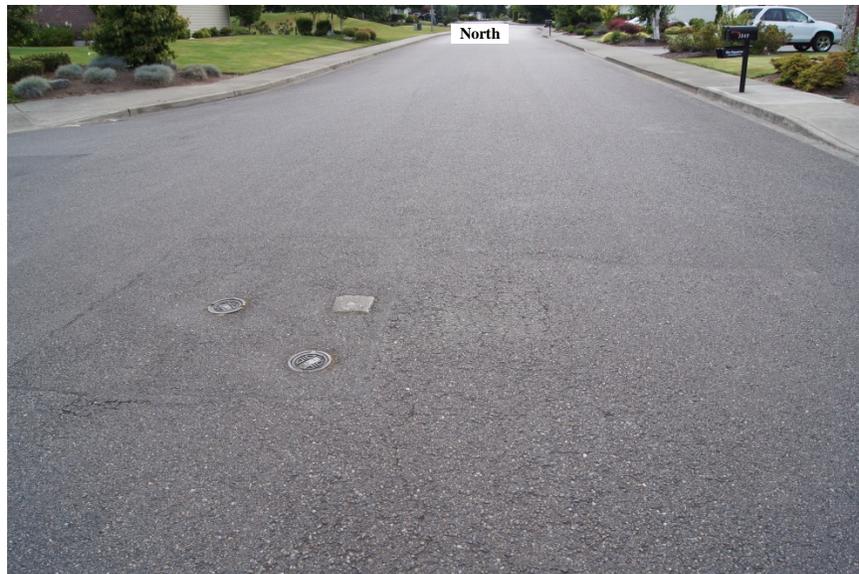
At the intersection of Prestwick Lane and Turnberry Lane, the pavement has alligator cracking and other signs of accelerated distress around the in-street appurtenances. PSI recommends that ISRC remove the pavement, recompact the base or subgrade, and replace the pavement around the utilities. Using the survey marker as the center point, the repairs should be made approximately 8 feet north-south and 8 feet east-west from the marker (Figure 9). Extend the pavement repair at least two feet beyond the areas of distress.

Figure 8. Distressed pavement at the intersection of Prestwick Lane and Turnberry Lane

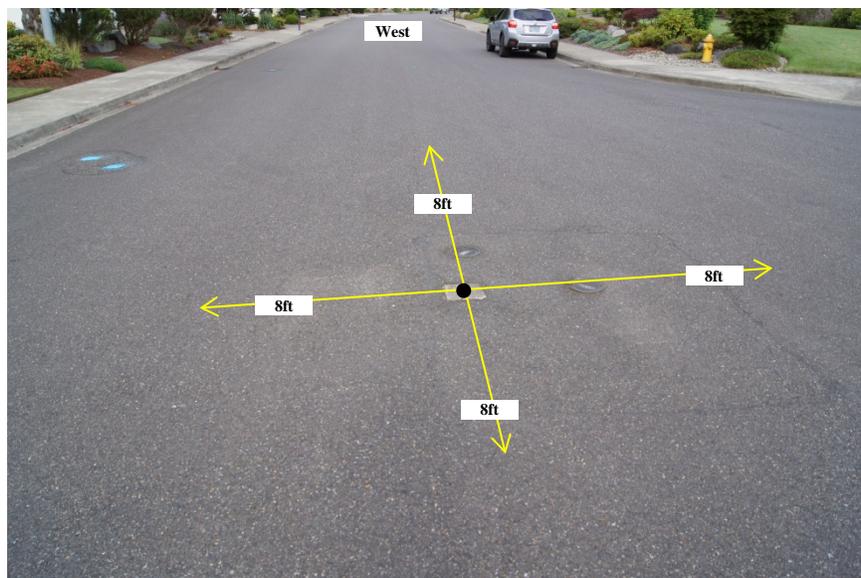
Figure 9. Recommended repair boundaries

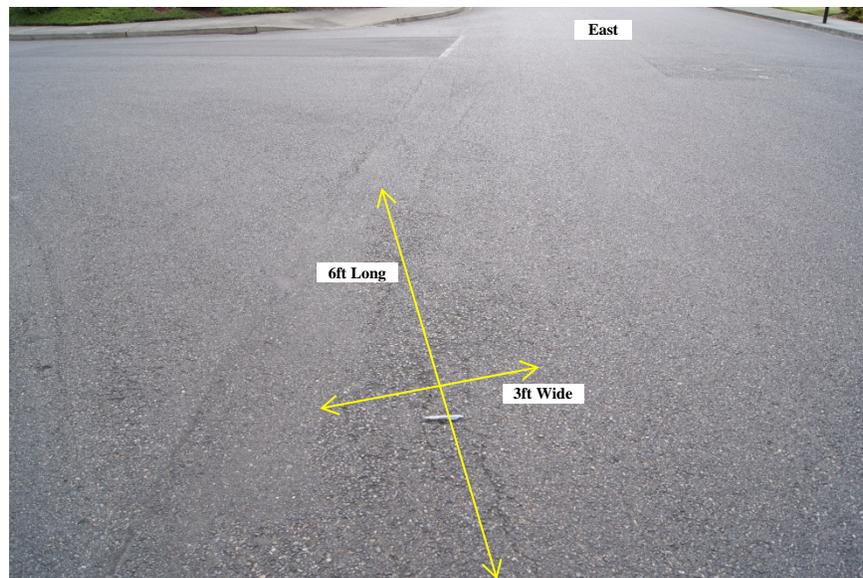
At the intersection of Prestwick Lane and Turnberry Lane there is alligator cracking near the northwest curb. We recommend that ISRC remove the pavement, recompact base or subgrade materials, and place and compact new AC. The repair should be approximately 3 feet wide by 6 feet long, or extend at least one foot beyond the area of distress.

Figure 10. Alligator cracking near the northwest curb at Turnberry Lane and Prestwick Lane

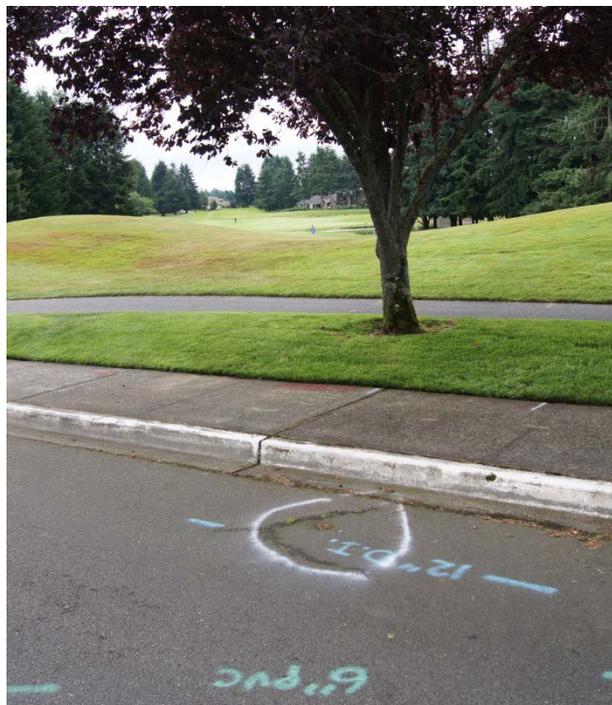
Along the east side of Troon Lane near the 9th hole of the Indian Summer golf course, roots from an adjacent tree (Figure 11) are causing cracking and a bump in the pavement. If possible, without damaging the health of the tree, we recommend that the roots be cut back, recompact the base or subgrade, and replace the pavement.

Figure 11. Tree Roots on Troon Lane

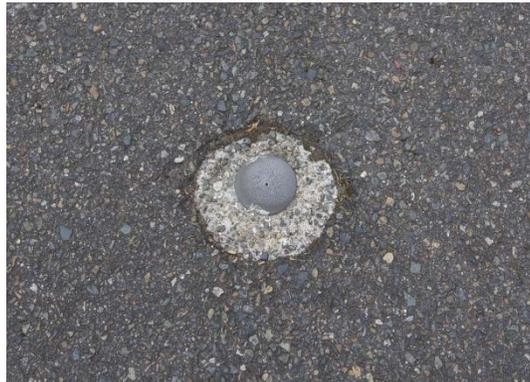
Figure 12. Example of a survey marker

We recommend preparing existing pavements prior to the application of any surface treatments or other maintenance work. Six to twelve months prior to applying the surface treatment, conduct crack sealing and patching, and correct any other issues affecting the ride quality or pavement performance. Immediately prior to applying the surface treatment, sweep the pavement of loose rock, dirt, and debris and cover utility inlets and survey markers (Figure 12) with heavy paper or roofing felt to prevent the surface treatment from obstructing these utilities for future use.

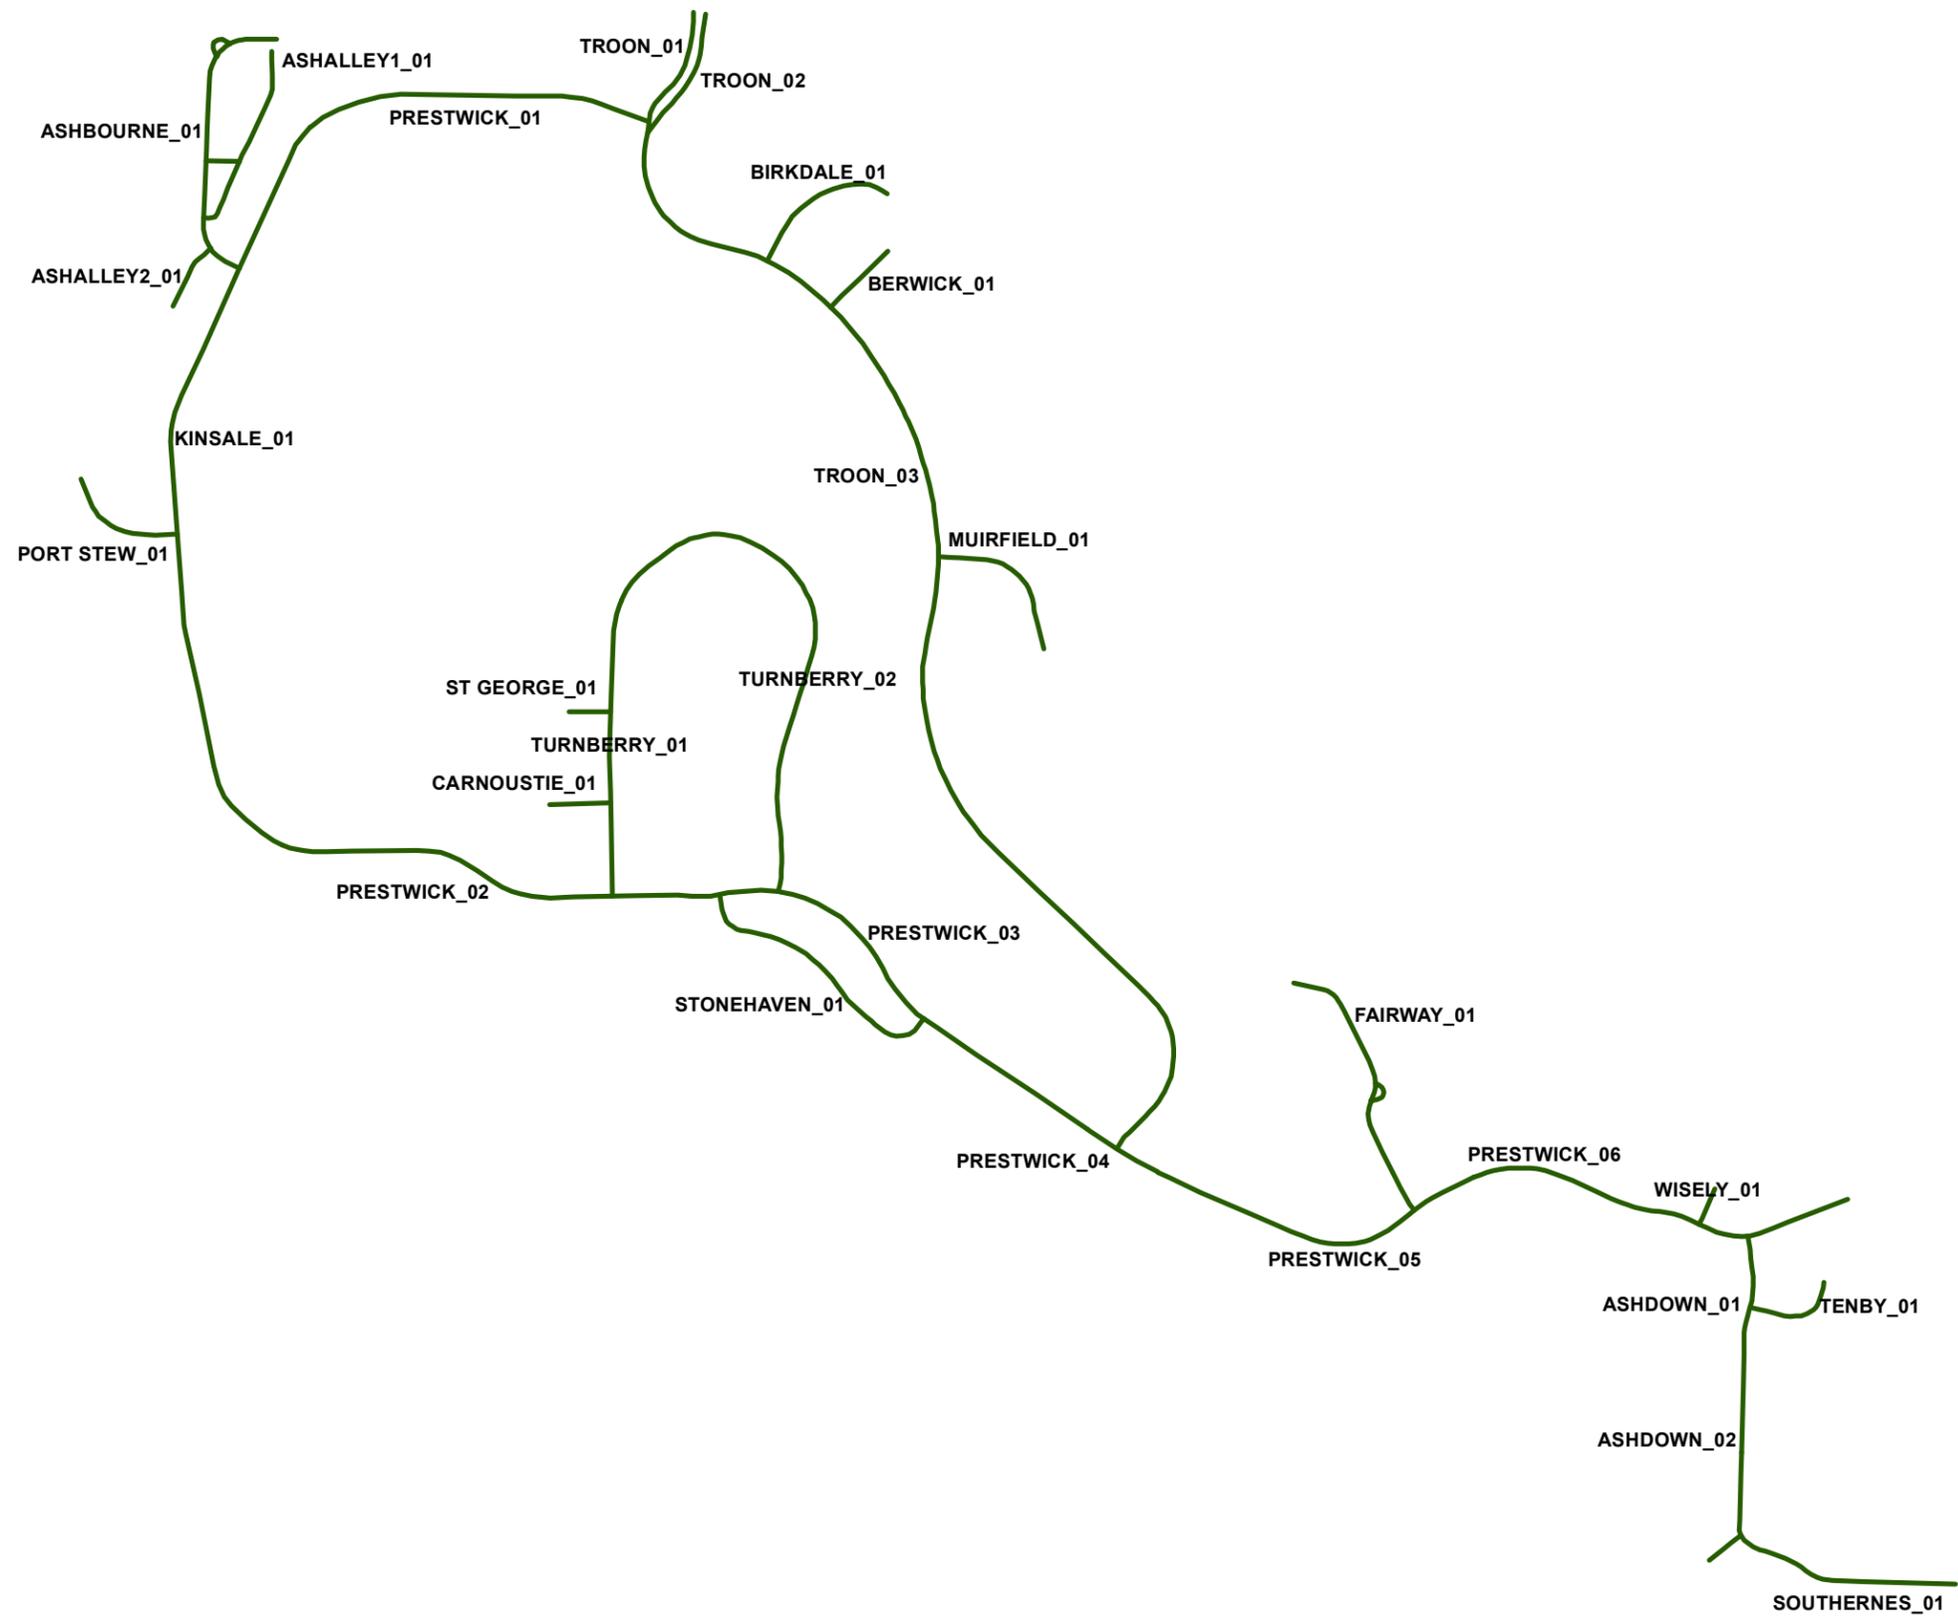
<i>Figure A.1</i>	
<i>Pavement Condition Index</i>	
<i>PCI Rating Year 2013</i>	
<i>Indian Summer Residential Community</i>	
<i>Olympia, Washington</i>

During the 2013 pavement condition survey, we found the all but one section of the pavements are in GOOD condition with the remainder in SATISFACTORY condition. The overall PCI for the Indian Summer streets is 92. PCI values for each section are listed in Appendix A, Table A.1, and are shown spatially in Figures A.1 and A.2.

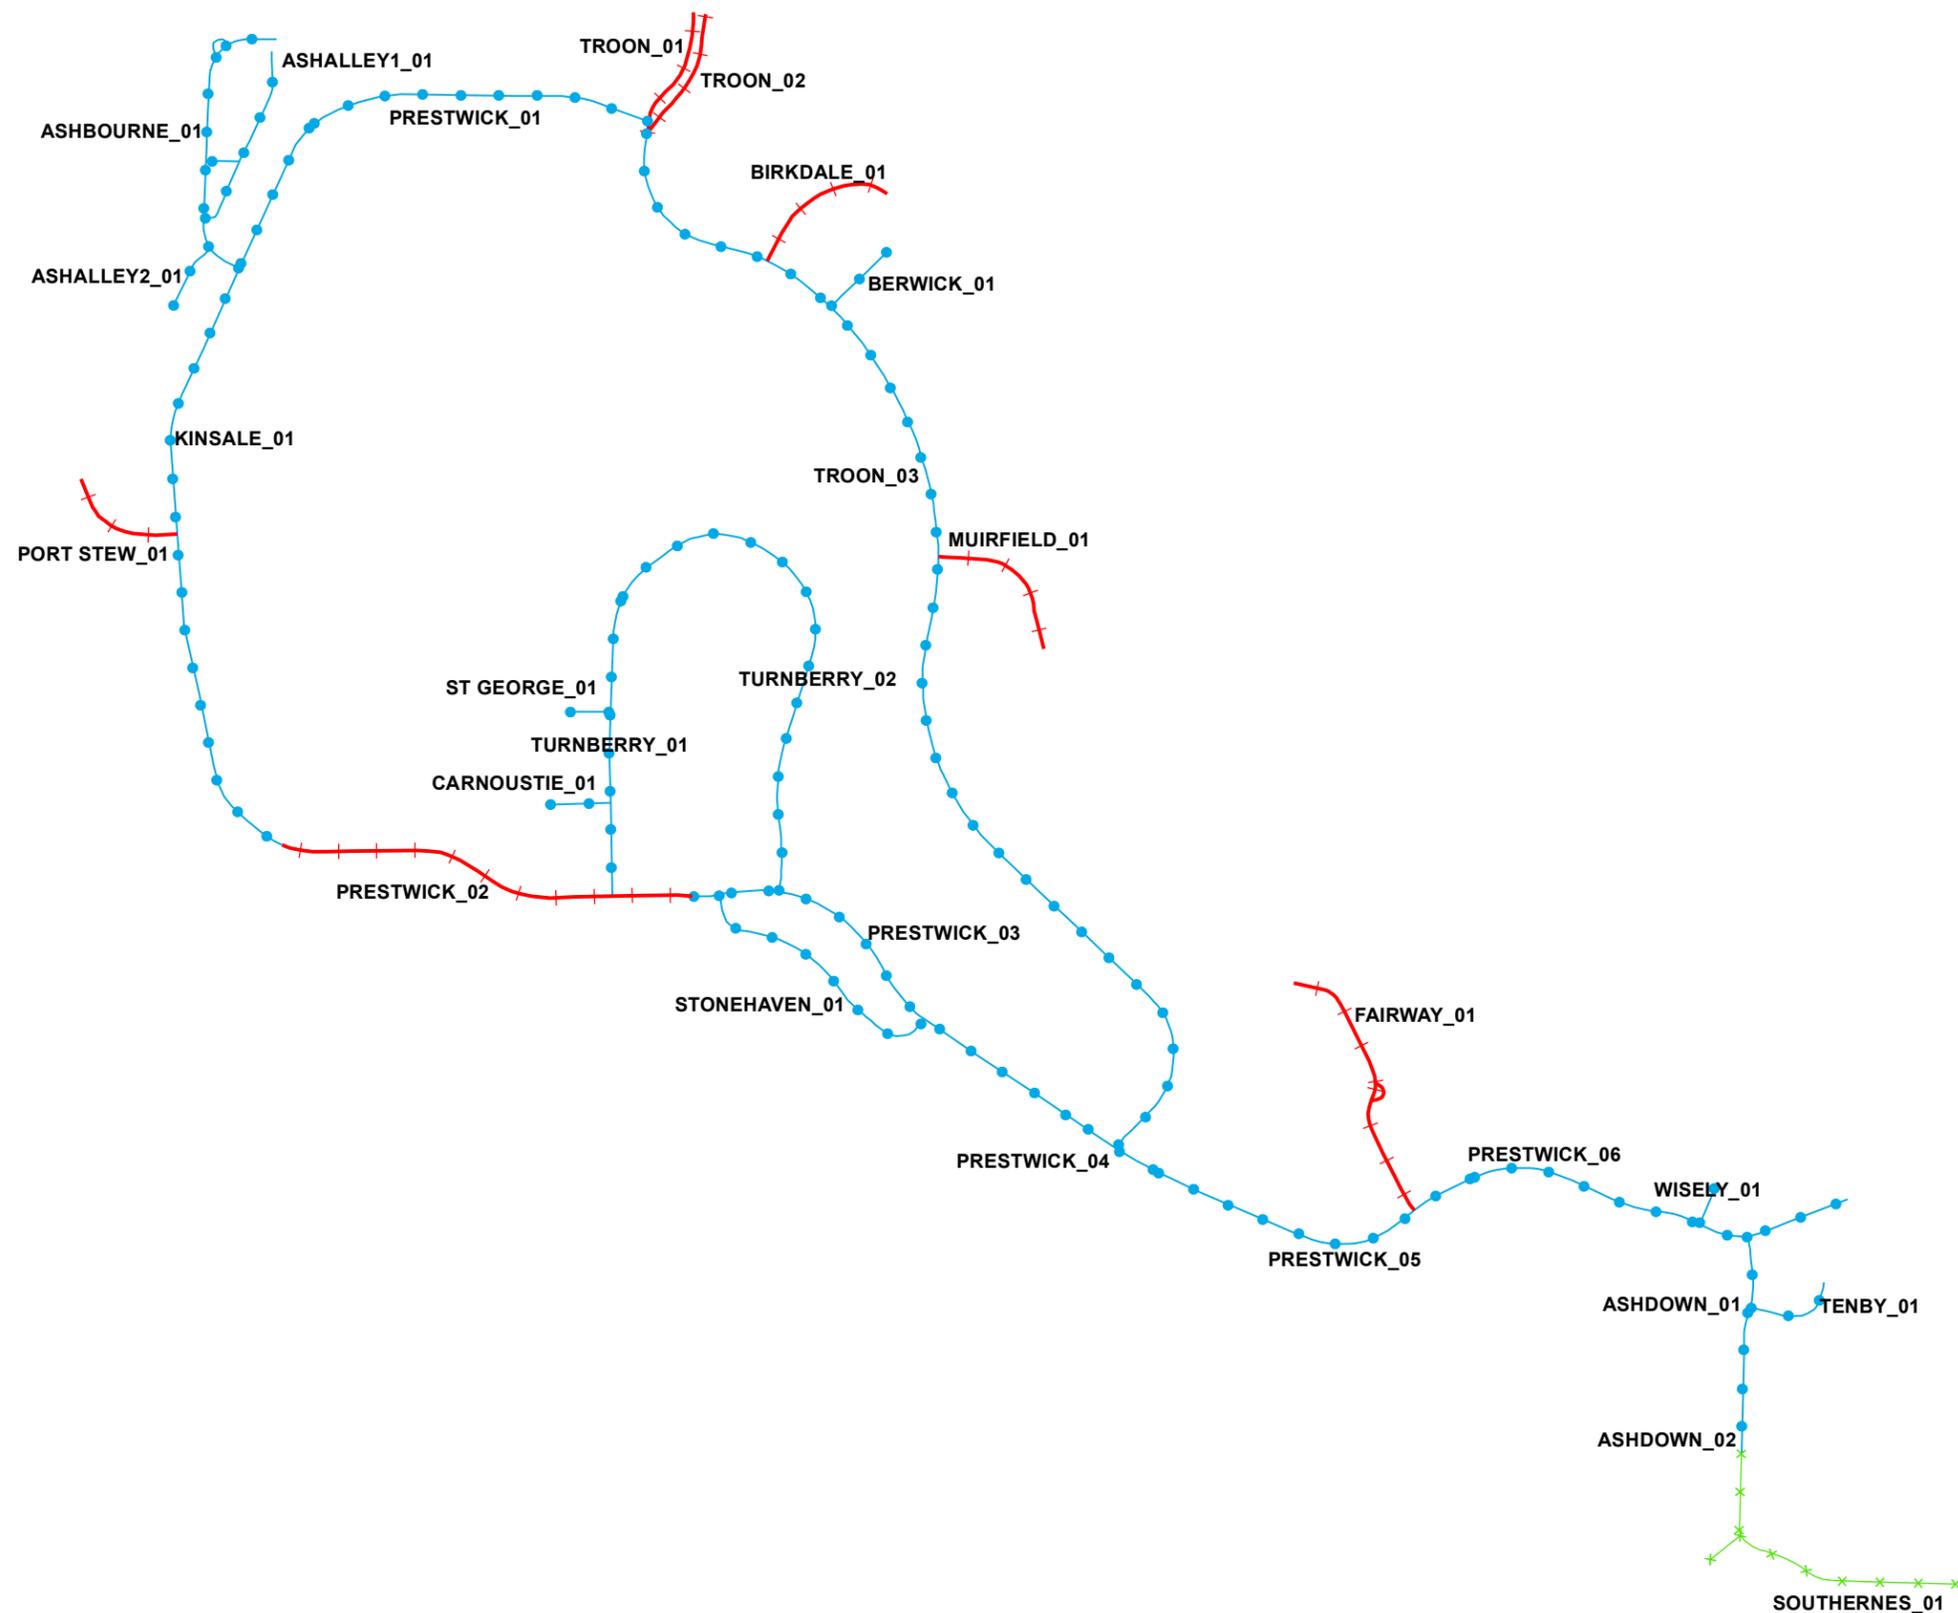
<i>Figure A.2</i>	
<i>PCI with Subcategories</i>	
<i>PCI Rating Year 2013</i>	
<i>Indian Summer Residential Community</i>	
<i>Olympia, Washington</i>

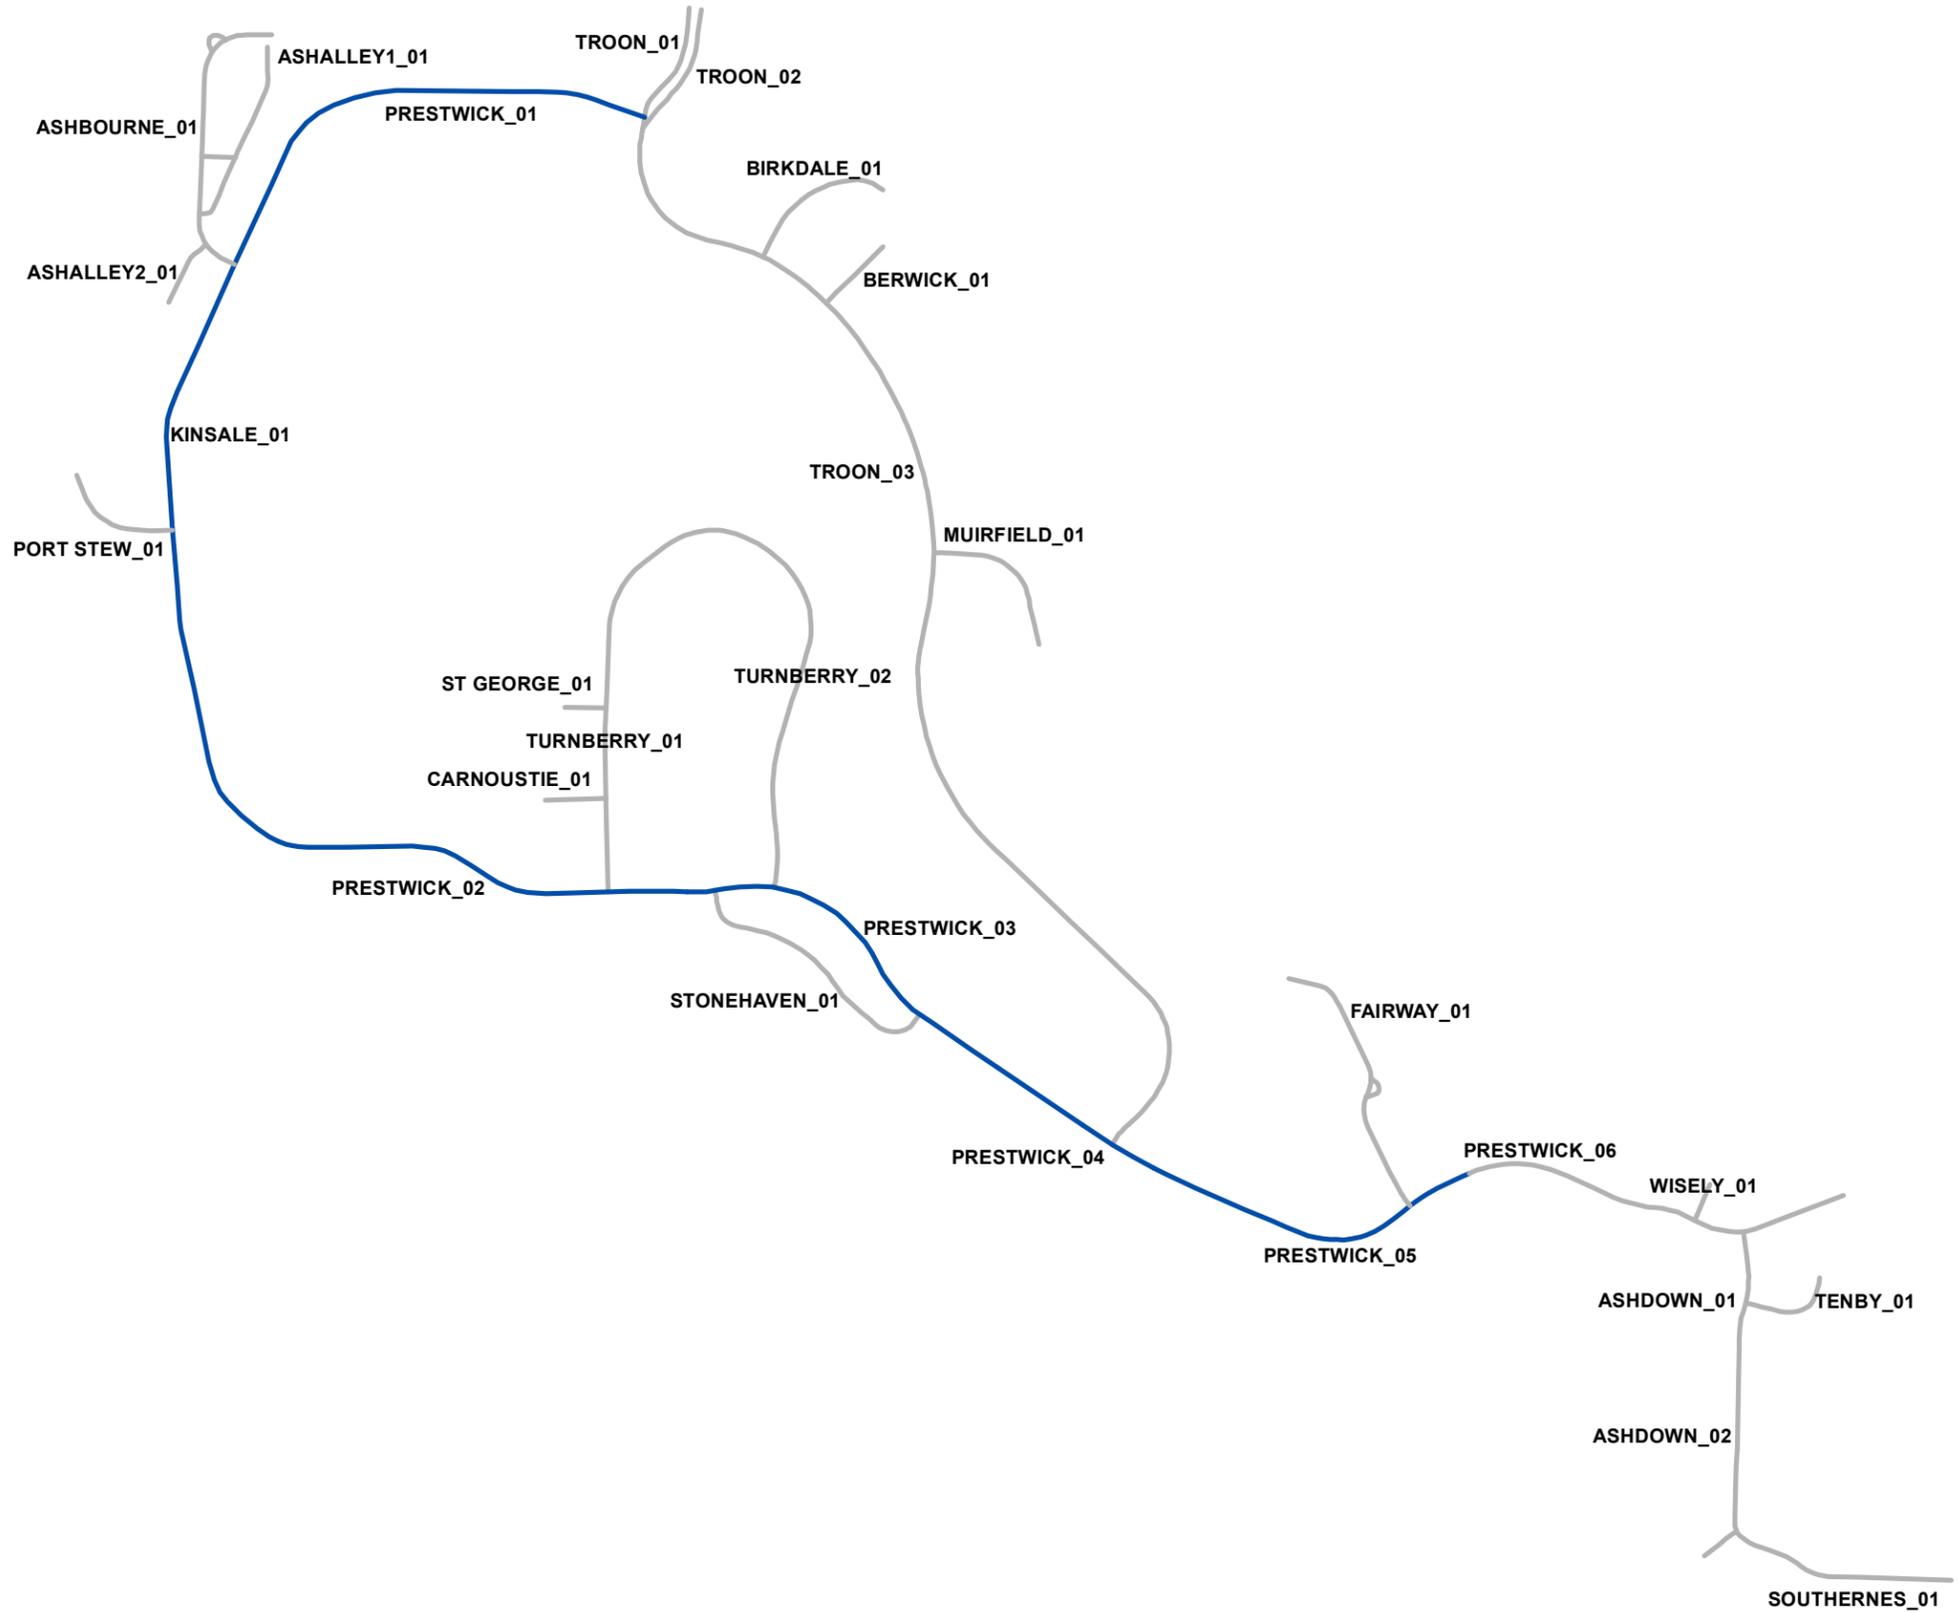
Figure B.1

M&R Recommendations
Projects for Year 2014

We prioritized M&R projects based upon the PCI, observed distresses and pavement use. The following table (Table 2) shows pavement sections grouped by year and recommended work type to create a four-year maintenance and repair plan. The projects are also shown on maps in Appendix B.

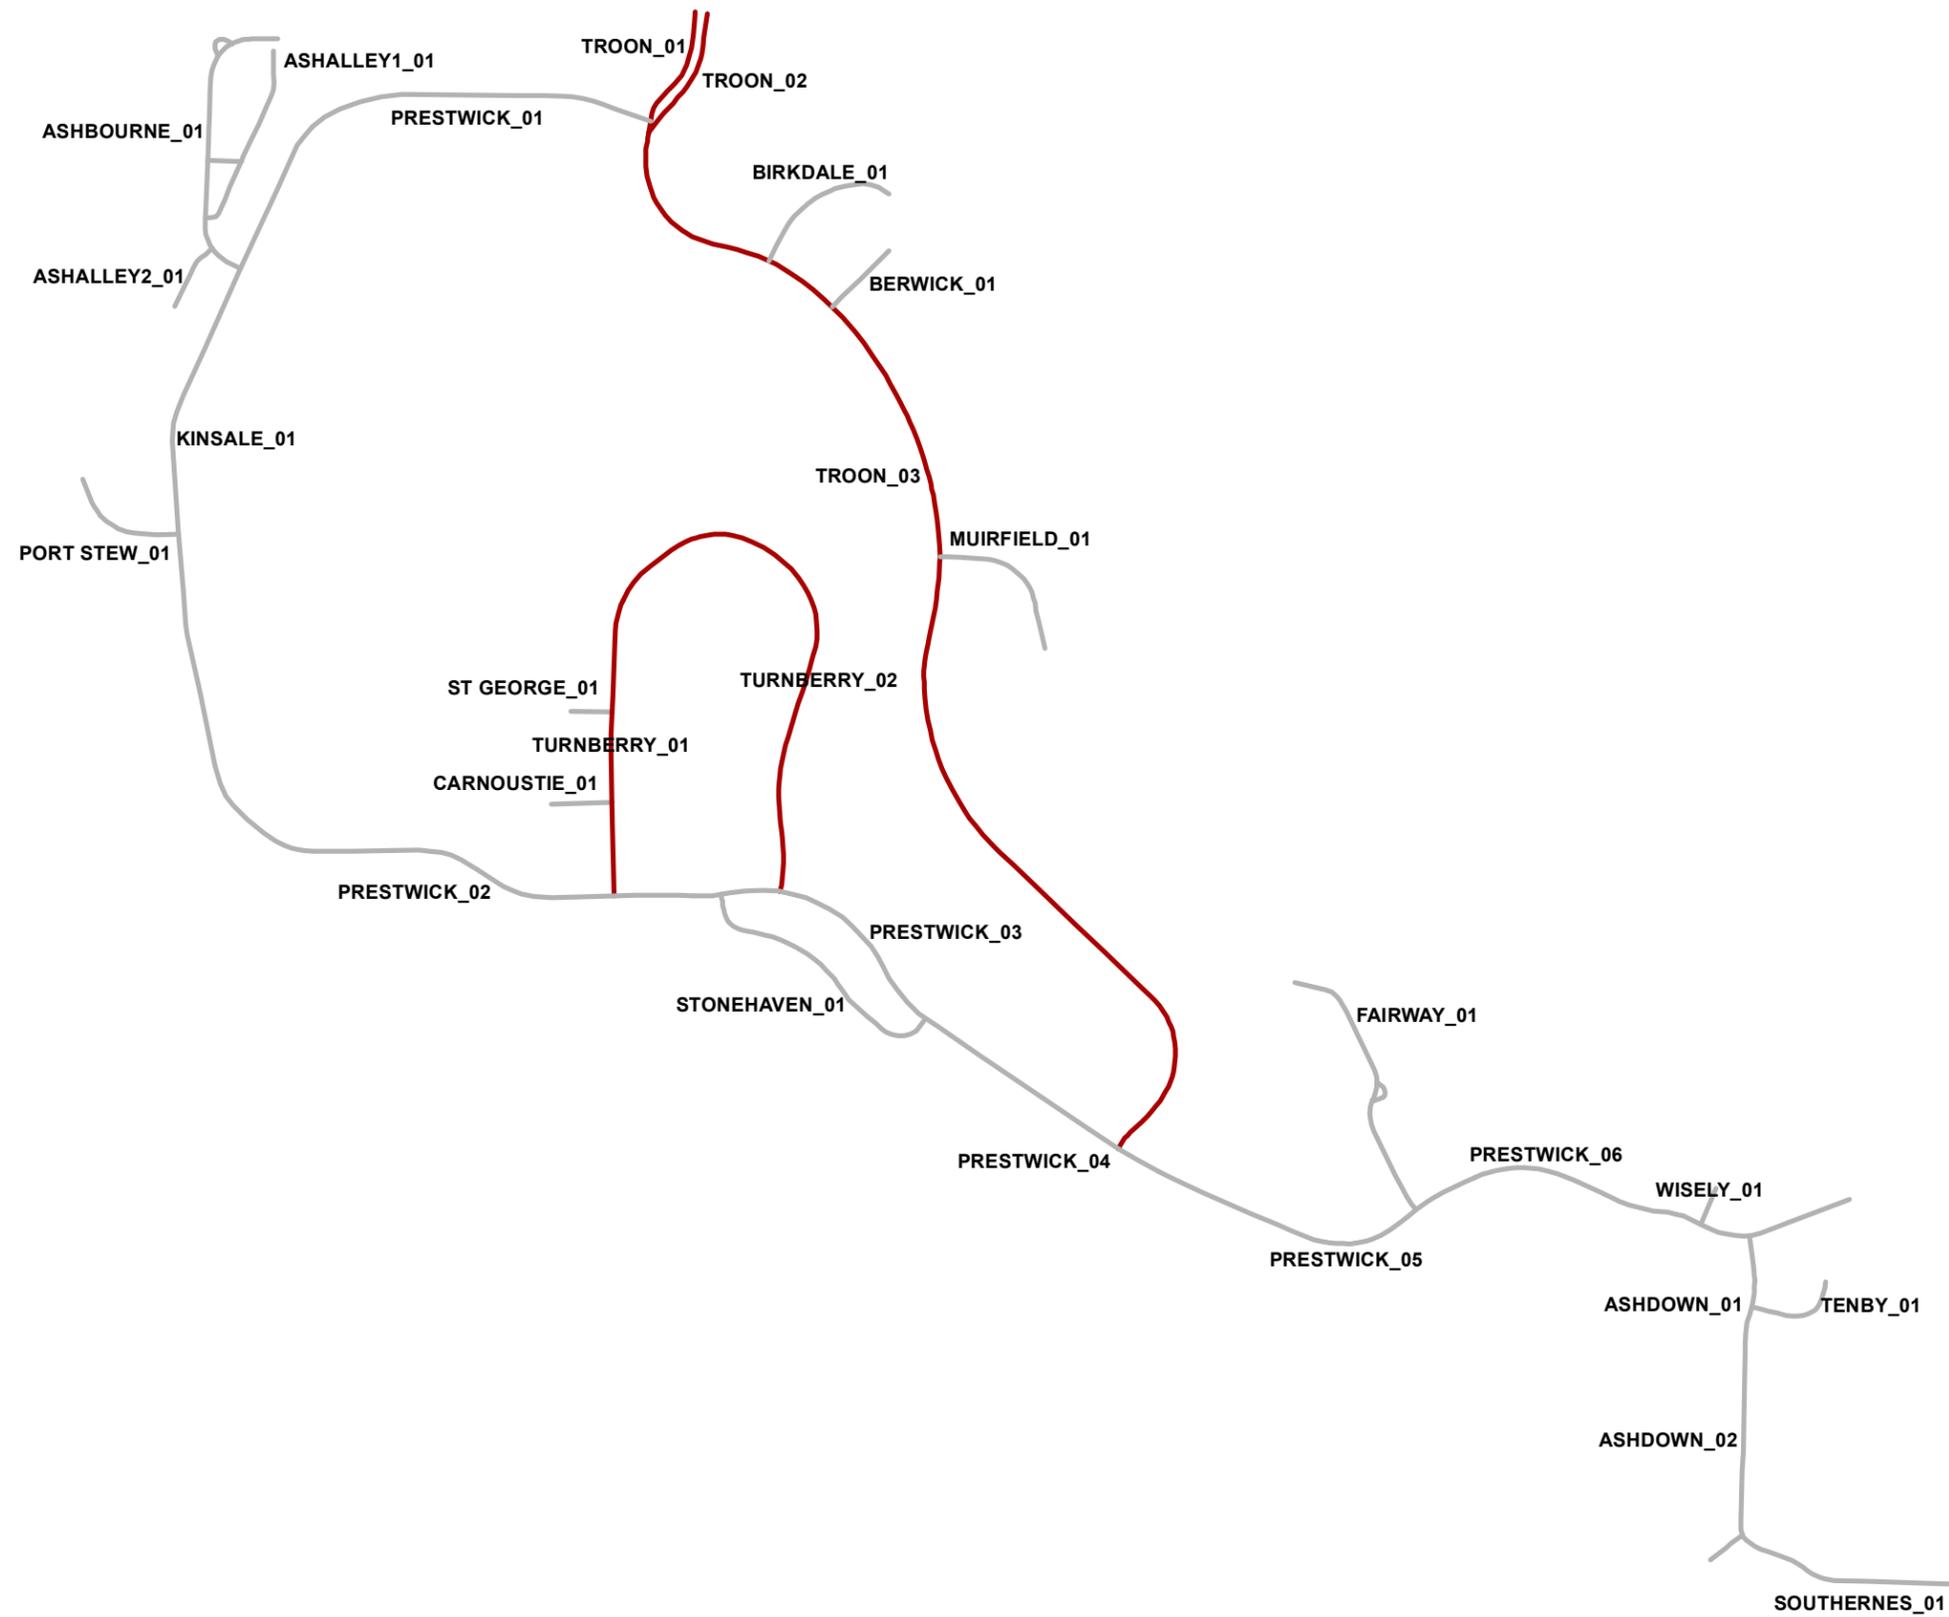
<i>Figure B.2</i>	
<i>M&R Recommendations</i> <i>Projects for Year 2015</i>	
<i>Indian Summer Residential Community</i> <i>Olympia, Washington</i>

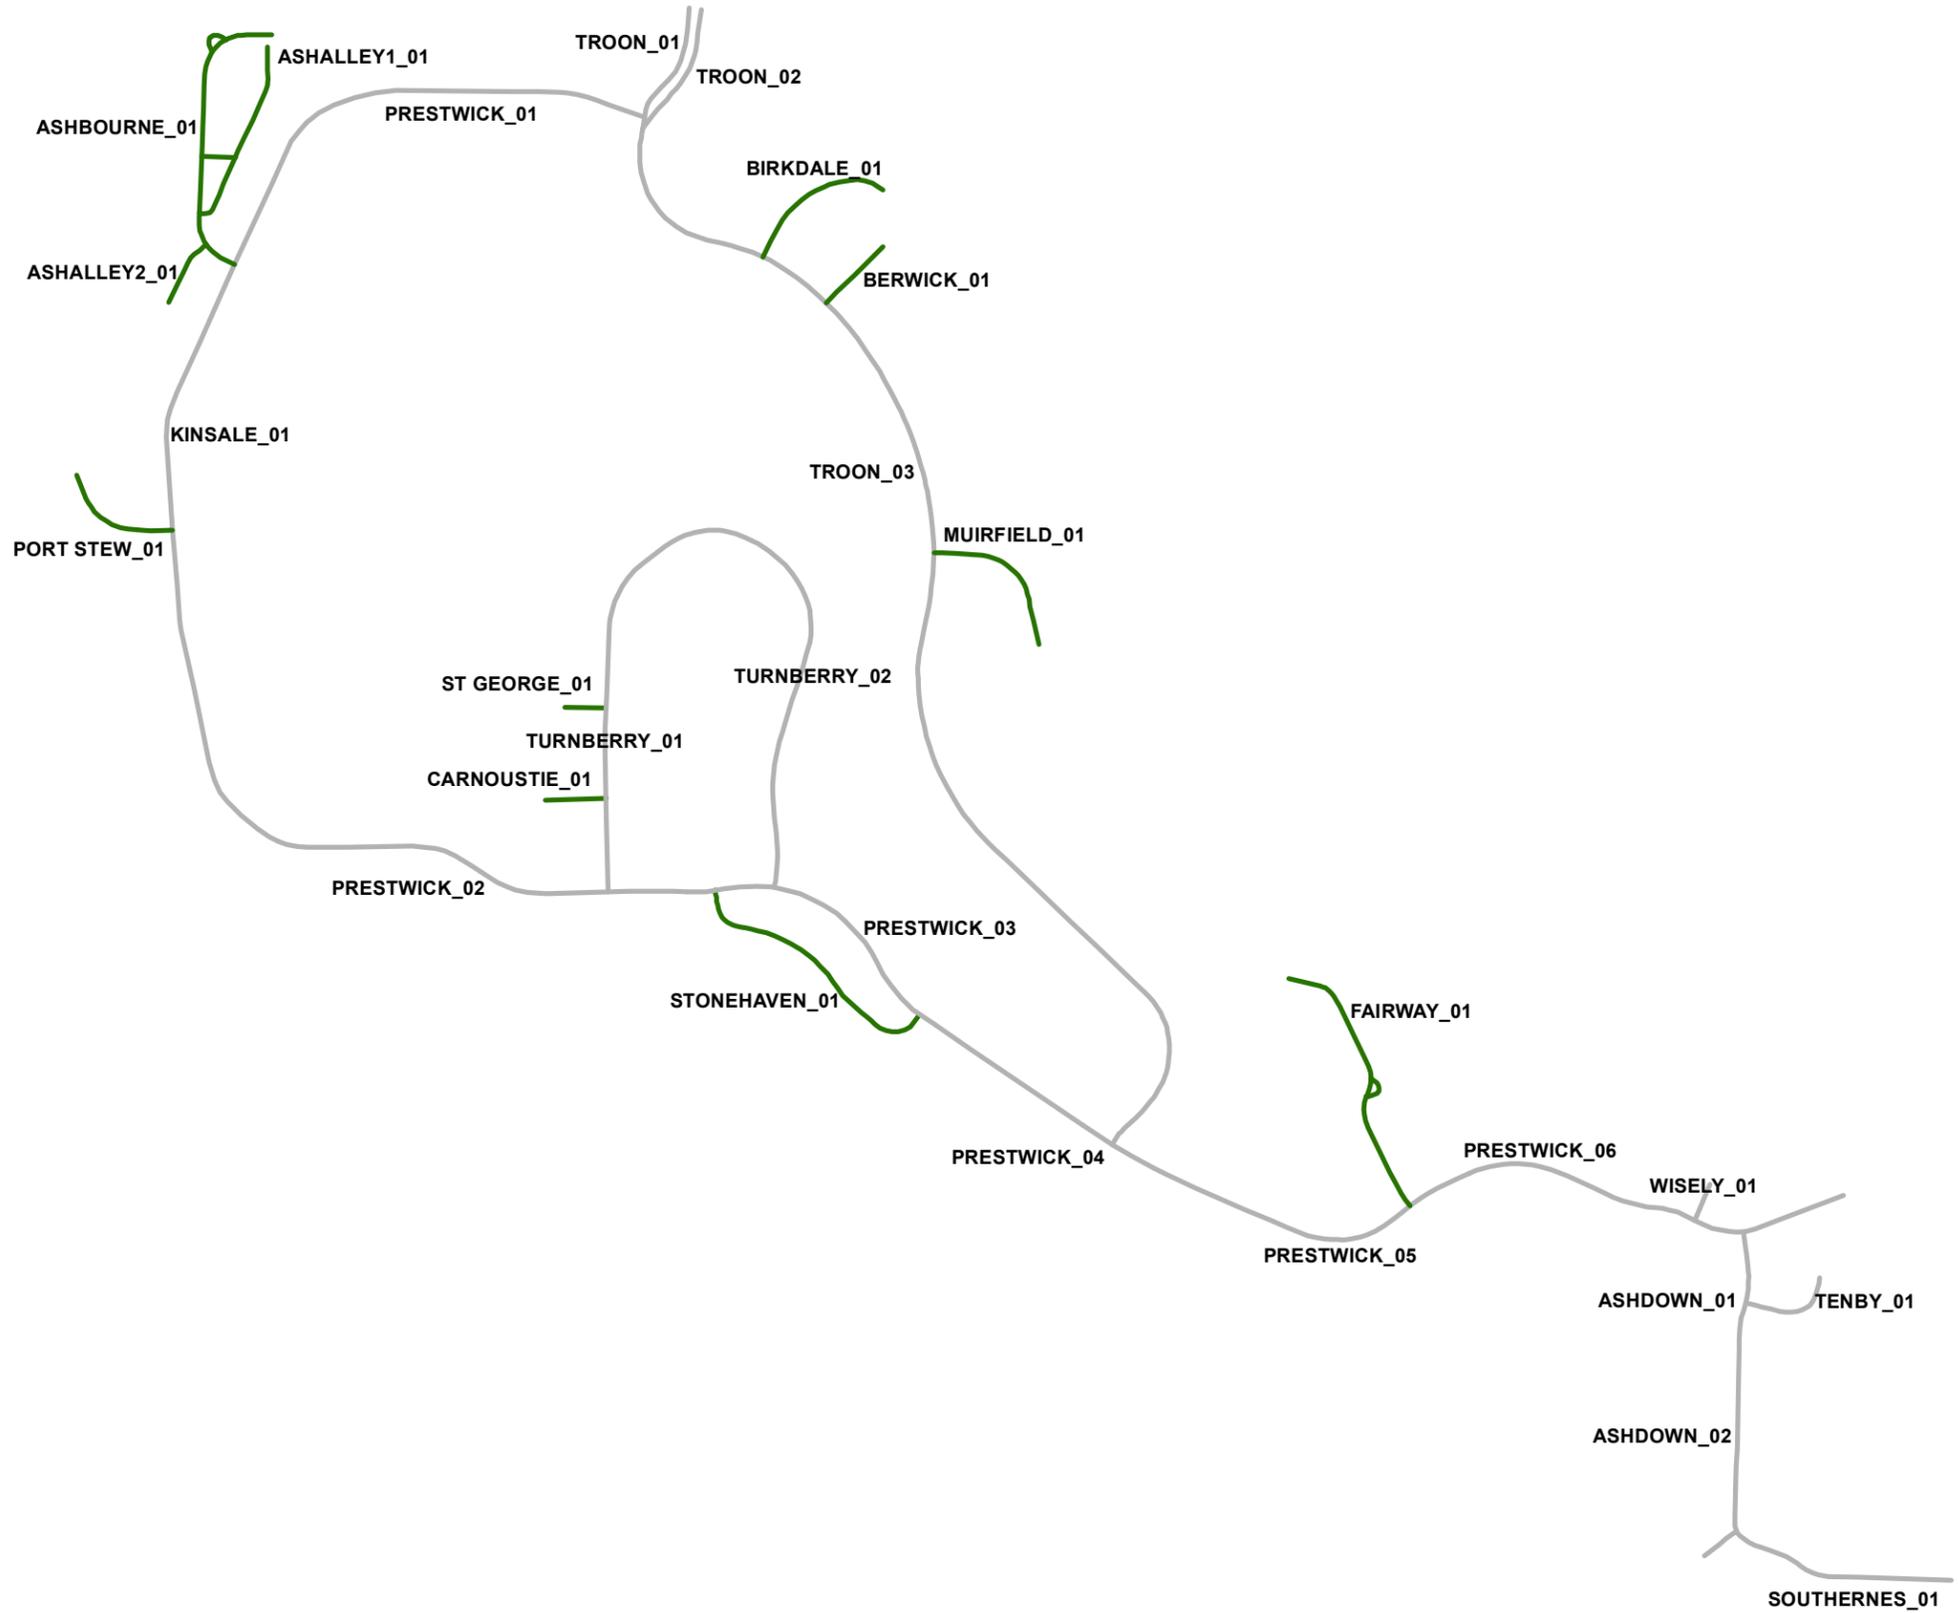
<i>Figure B.3</i>	
<i>M&R Recommendations</i>	
<i>Projects for Year 2016</i>	
<i>Indian Summer Residential Community</i>	
<i>Olympia, Washington</i>
