**Indian Summer Residential Community
Pavement Maintenance and Repair Prioritization Plan (2014 – 2017)**
August 30, 2013

Vantage Community Management
Barbara Brauser
202 Central Street NE, Suite 140
Olympia, WA 98506

PAVEMENT SERVICES, INC.
3835 NE Tillamook Street
Portland, Oregon 97212
(503) 235-0377

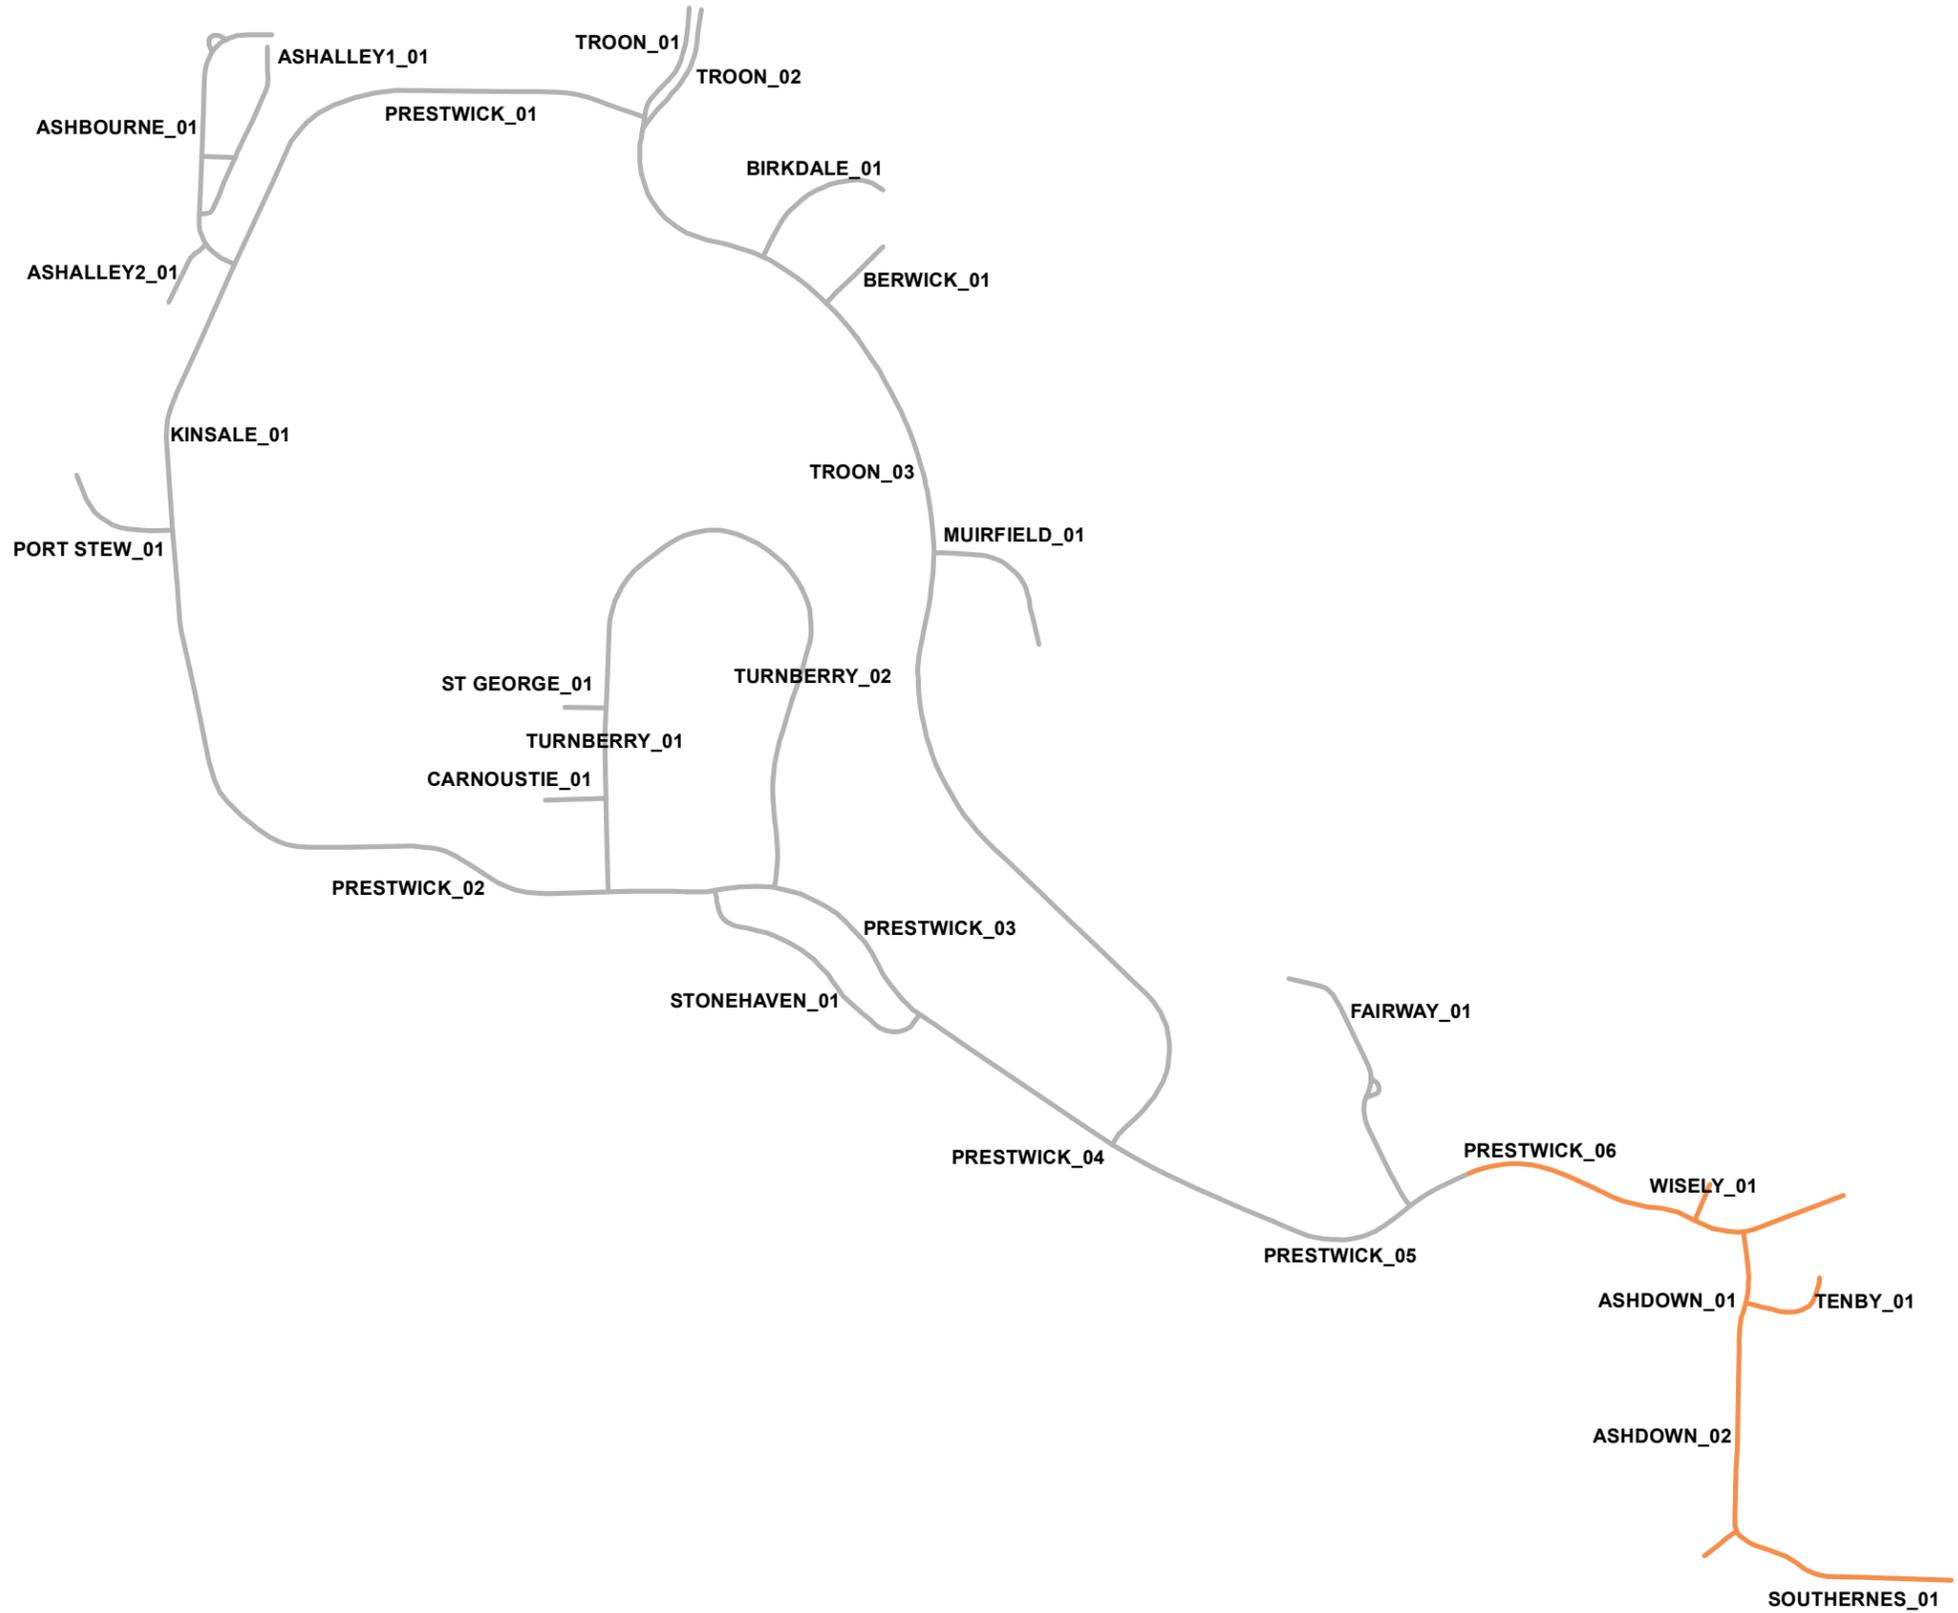
<i>Figure B.4</i>	
<i>M&R Recommendations</i>	
<i>Projects for Year 2017</i>	
<i>Indian Summer Residential Community</i>	
<i>Olympia, Washington</i>

We prioritized M&R projects based upon the PCI, observed distresses and pavement use. The following table (Table 2) shows pavement sections grouped by year and recommended work type to create a four-year maintenance and repair plan. The projects are also shown on maps in Appendix B.
